(c) NATIONAL PHOTOGRAPHIC INTERPRETATION CENTER

Attachment	to l	<b>1-83</b>	90/7	73
	11 December			1973
•	Page	_1_	of	2
	Сору

REFERENCE TO: GIANT REACH MISSION XA010,

# EGYPTIAN CAUSEWAY CONSTRUCTION SUEZ CANAL, EGYPT

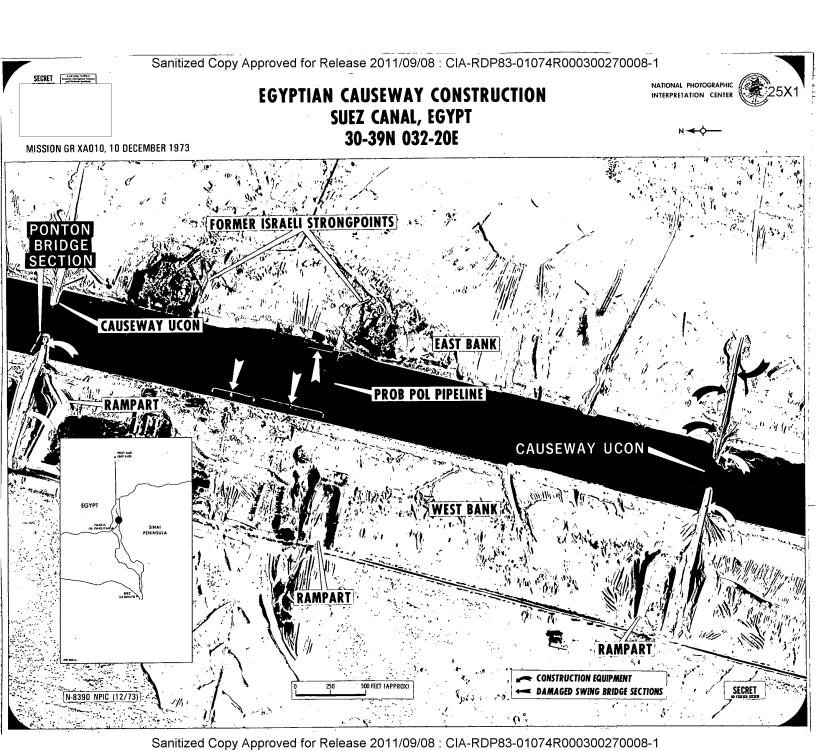
- EGYPTIAN CAUSEWAY CONSTRUCTION CONTINUES. THE

PREVIOUSLY IDENTIFIED POSSIBLE CAUSEWAY IS NOW

CONFIRMED AS A CAUSEWAY UNDER CONSTRUCTION.
- 2. REMARKS:

3. MISSION READOUT: ONE CAUSEWAY UNDER CONSTRUCTION IS 5.7 NAUTICAL MILES (NM) NORTH OF ISMAILIA AT 30-39-55N 032-20-10E. EARTH FILL EXTENDED ONE-THIRD THE WIDTH OF THE CANAL FROM BOTH THE EAST AND WEST BANKS. FROM THE WEST BANK, THE CAUSEWAY WAS BEING CONSTRUCTED THROUGH AN EXISTING DEFENSIVE EARTHEN RAMPART. A PONTON BRIDGE SECTION WAS ADJACENT TO THE EARTH FILL ON THE WEST BANK. CONSTRUCTION EQUIPMENT WAS OBSERVED ON THE WEST BANK EXTENSION.
